FIRST ENDORSEMENT on VF-142 AAR 4-56 concerning FJ-3 BuNo 139223
accident occurring 8 June 1956, Pilot LTJG Glen
E. GRABER; addendum to dtd 7 November 1956

From: Aircraft Accident Report
To: Chief of Naval Operations (OP-57)
Via: (1) Commanding Officer Fighter Squadron ONE HUNDRED FORTY TWO
(2) Commander, Carrier Air Group FOURTEEN
(3) Commander, Air Force Pacific Fleet
(4) Director, Naval Aviation Safety Center
Subj: VF-142 AAR 4-56 concerning FJ-3 BuNo 139223 accident occurring 8 June 1956, Pilot LTJG Glen E. GRABER; addendum to

AIRCRAFT ACCIDENT REPORT

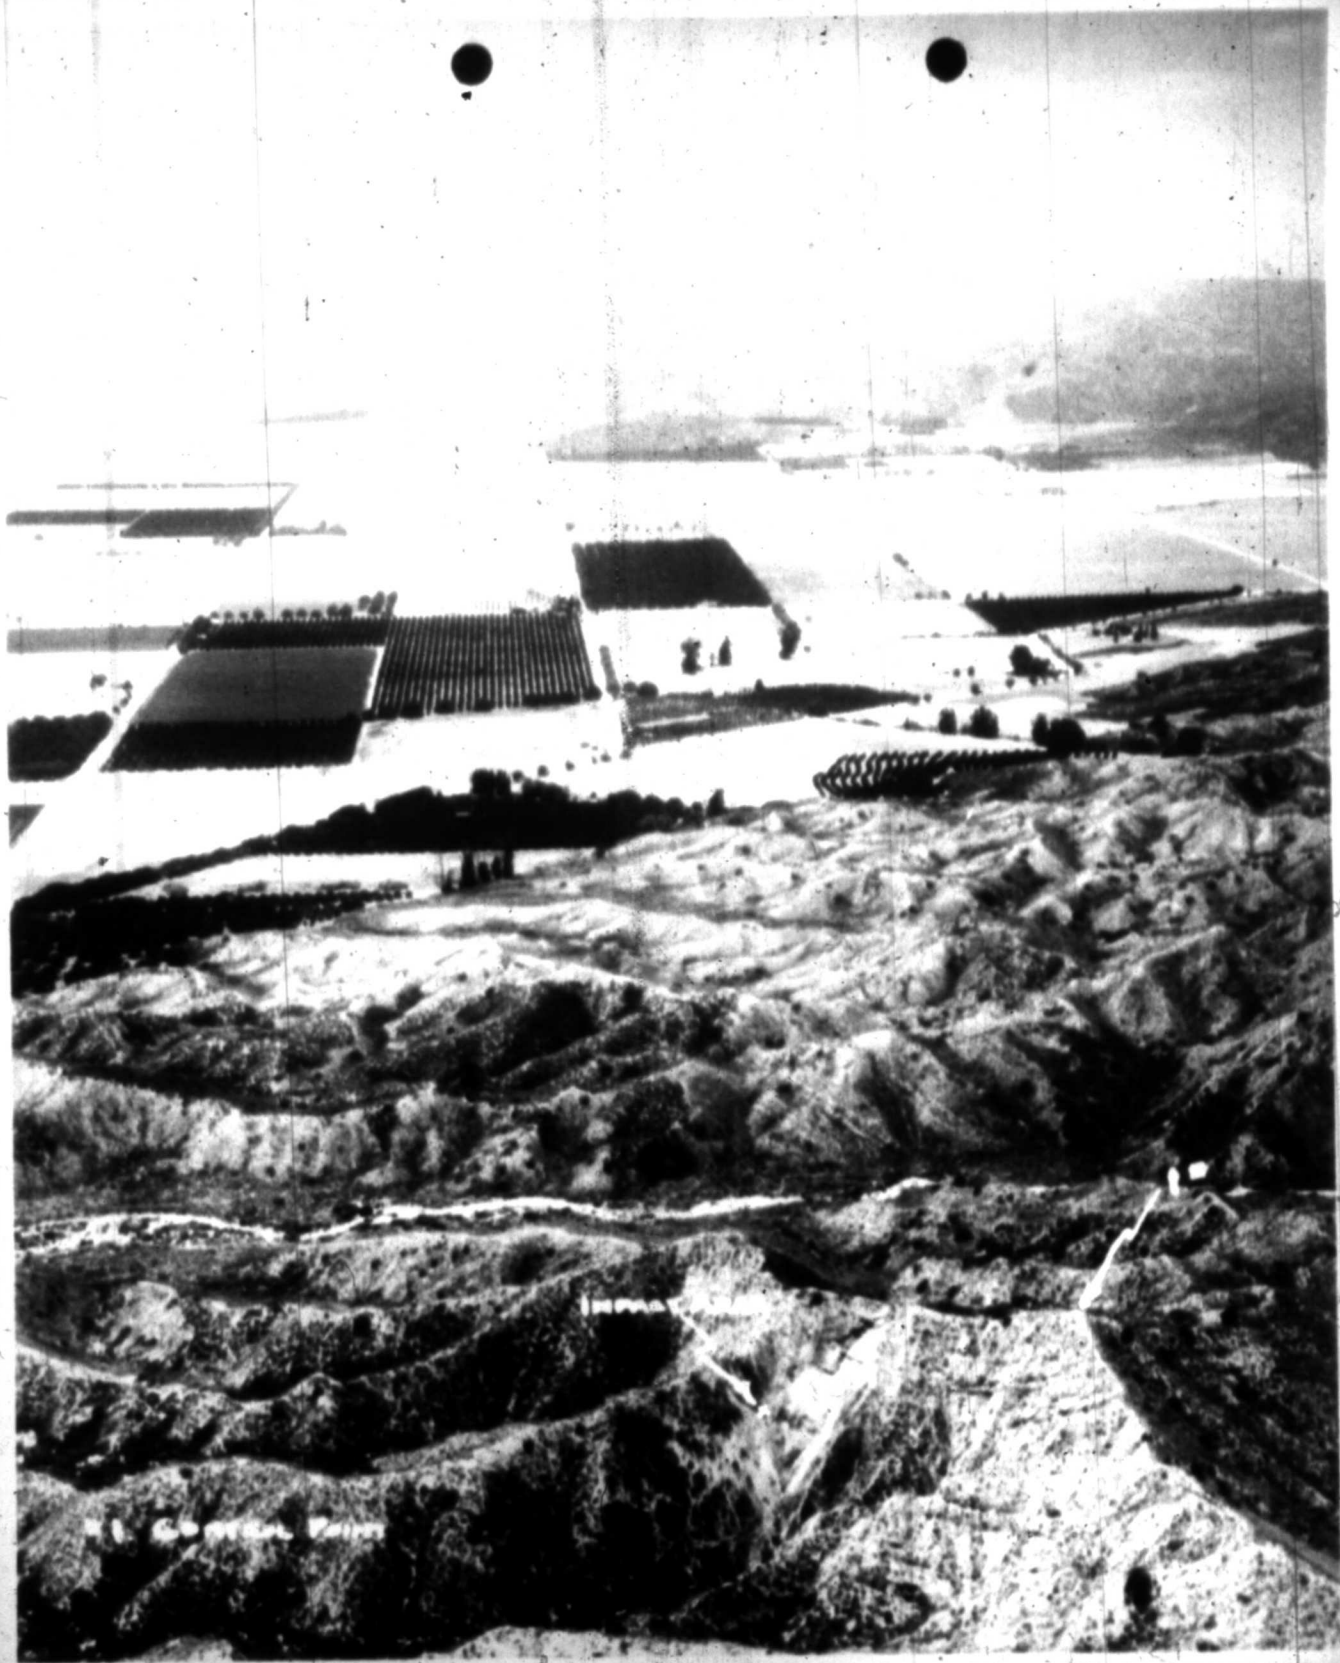
ENCLOSURE 2-2

(6) The ejection seat was located in the position shown on enclosure 8b. The ejection charge had been fired.

(7) The canopy ejector was found in the position shown on enclosure 8b. The ejection charge had not been fired.

(11) The burner section, turbine section and tail pipe section of the engine were located at the bottom of the canyon as shown in the wreckage diagram enclosure 8a & 8b. Six and one half hours after the crash the turbine blades were too hot to touch by hand. The shell of the engine, which had been exposed to the fire caused by the crash, was at a considerably cooler temperature at this time.

WRECKAGE

DIAGRAM

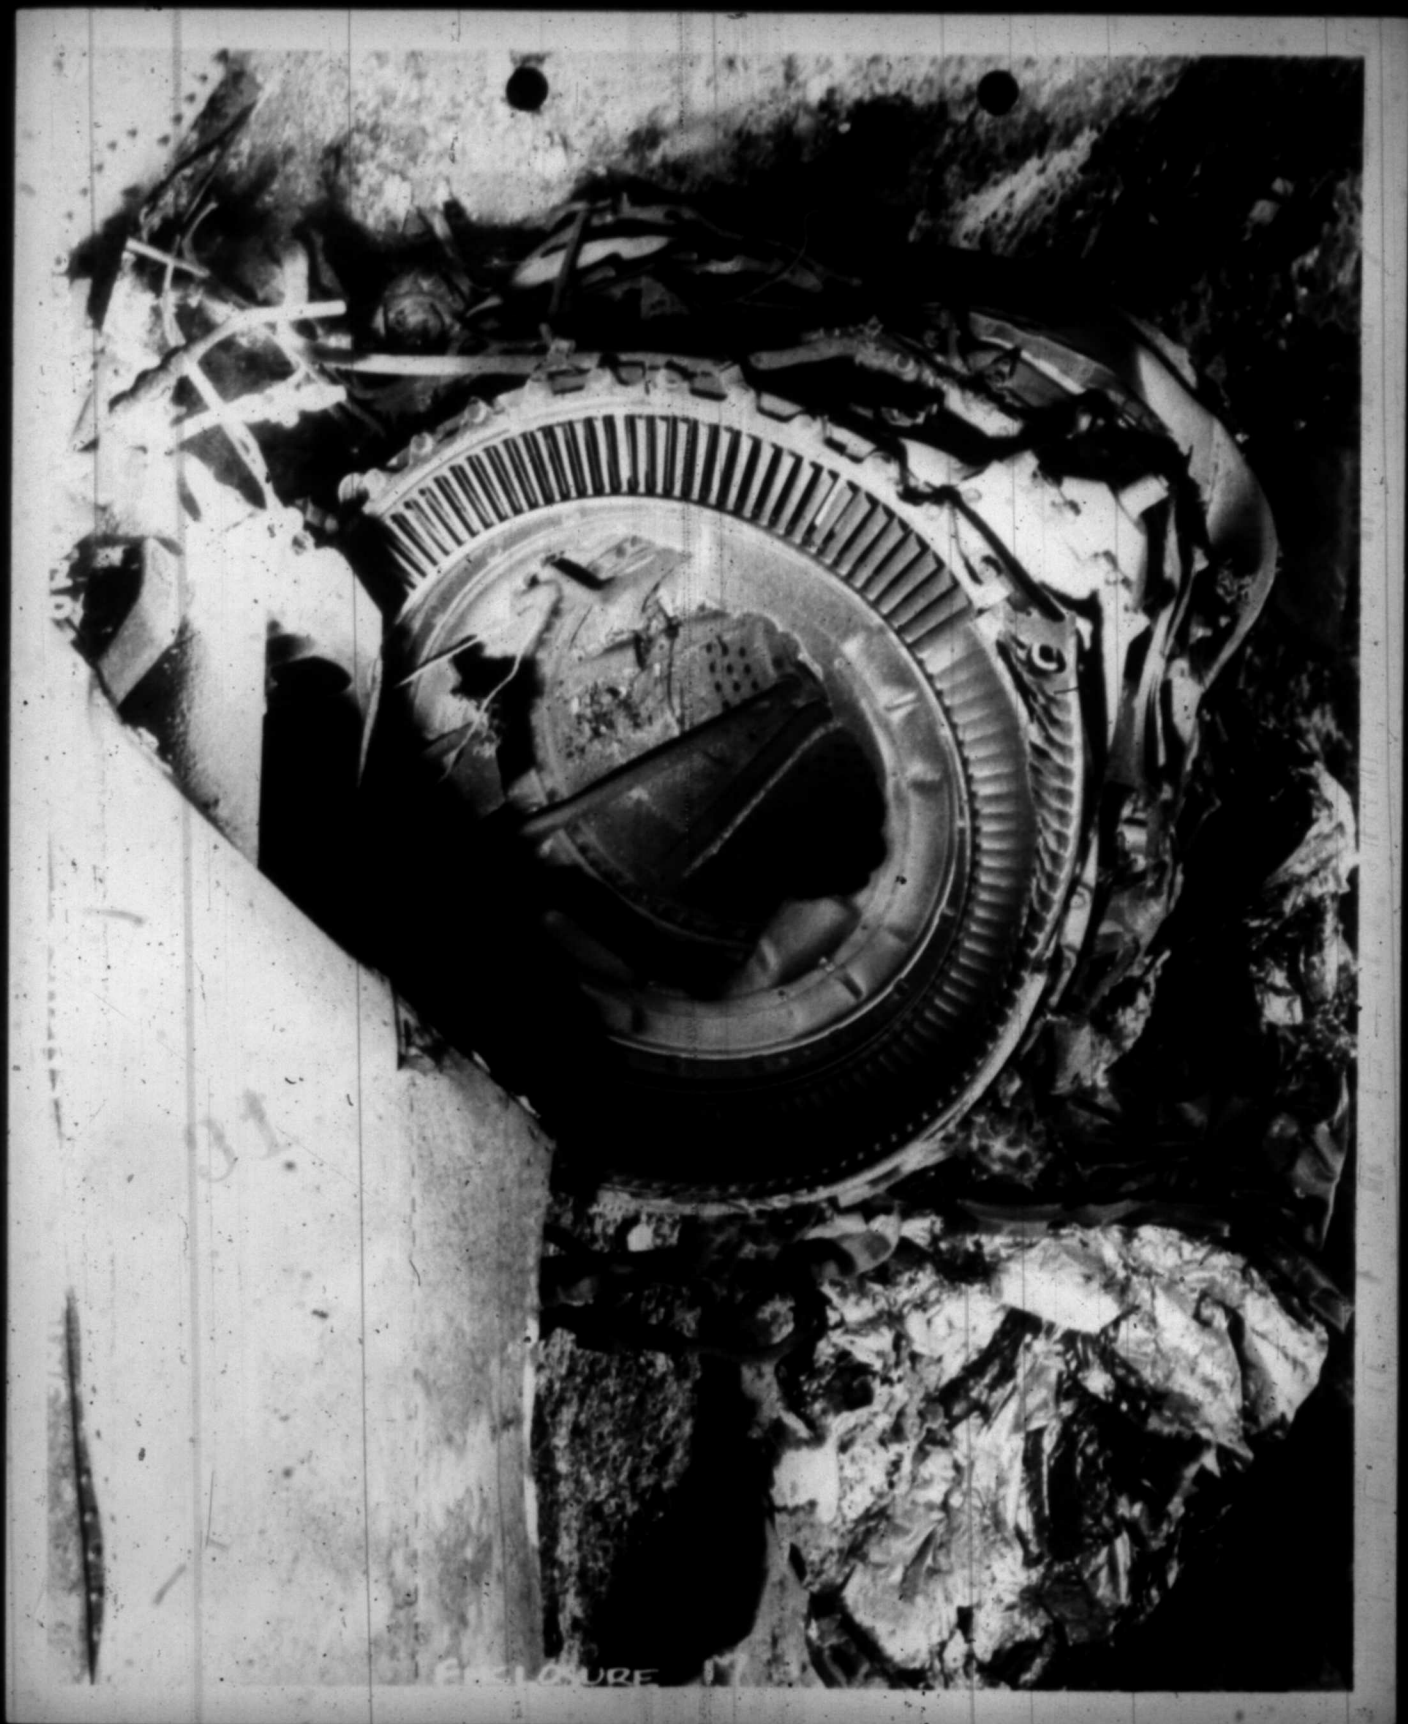
(10) The compressor section of the engine was located 215 feet from the impact area. The first three stages of the compressor were completely missing. The compressor blades were broken off of stages 4, 5, and 6. The blades of stages 7, 8, and 9 were deflected 45 to 90 degrees opposite to the direction of normal rotation. The blades on stages 10, 11, and 12 were nicked and slightly bent. (See enclosure 16).

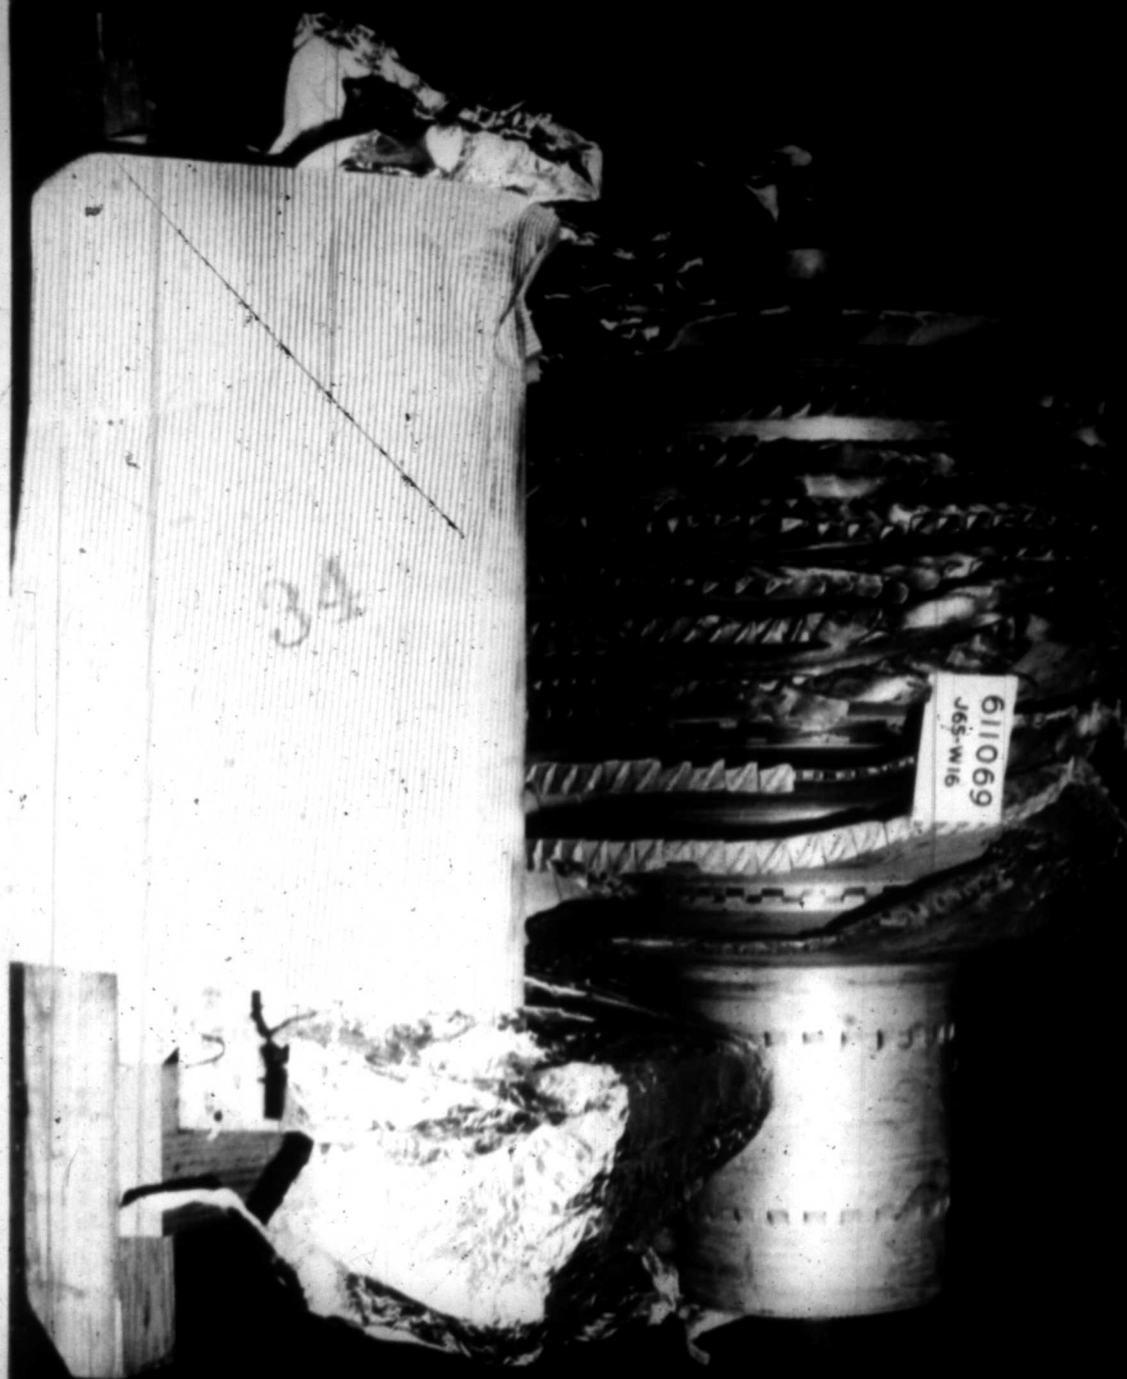
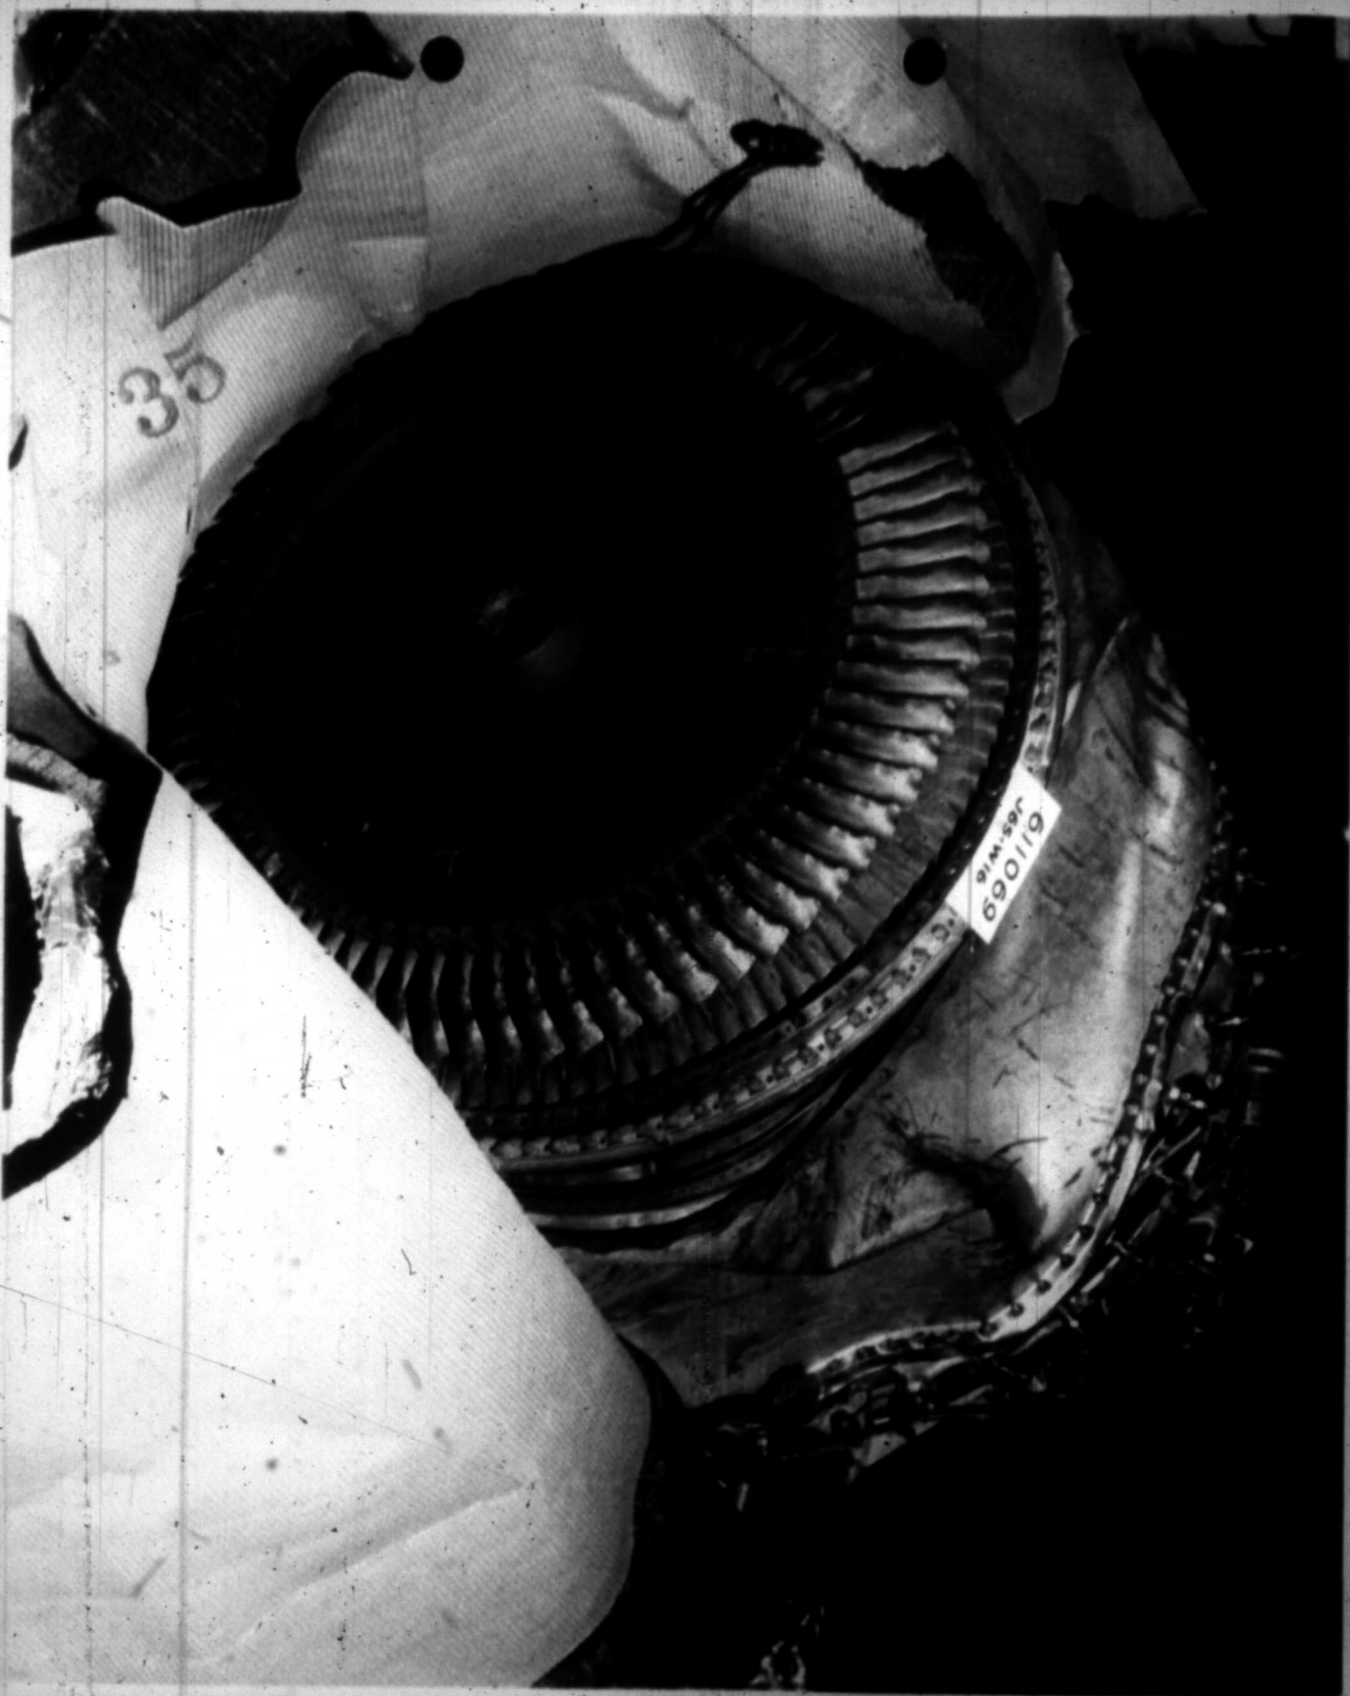
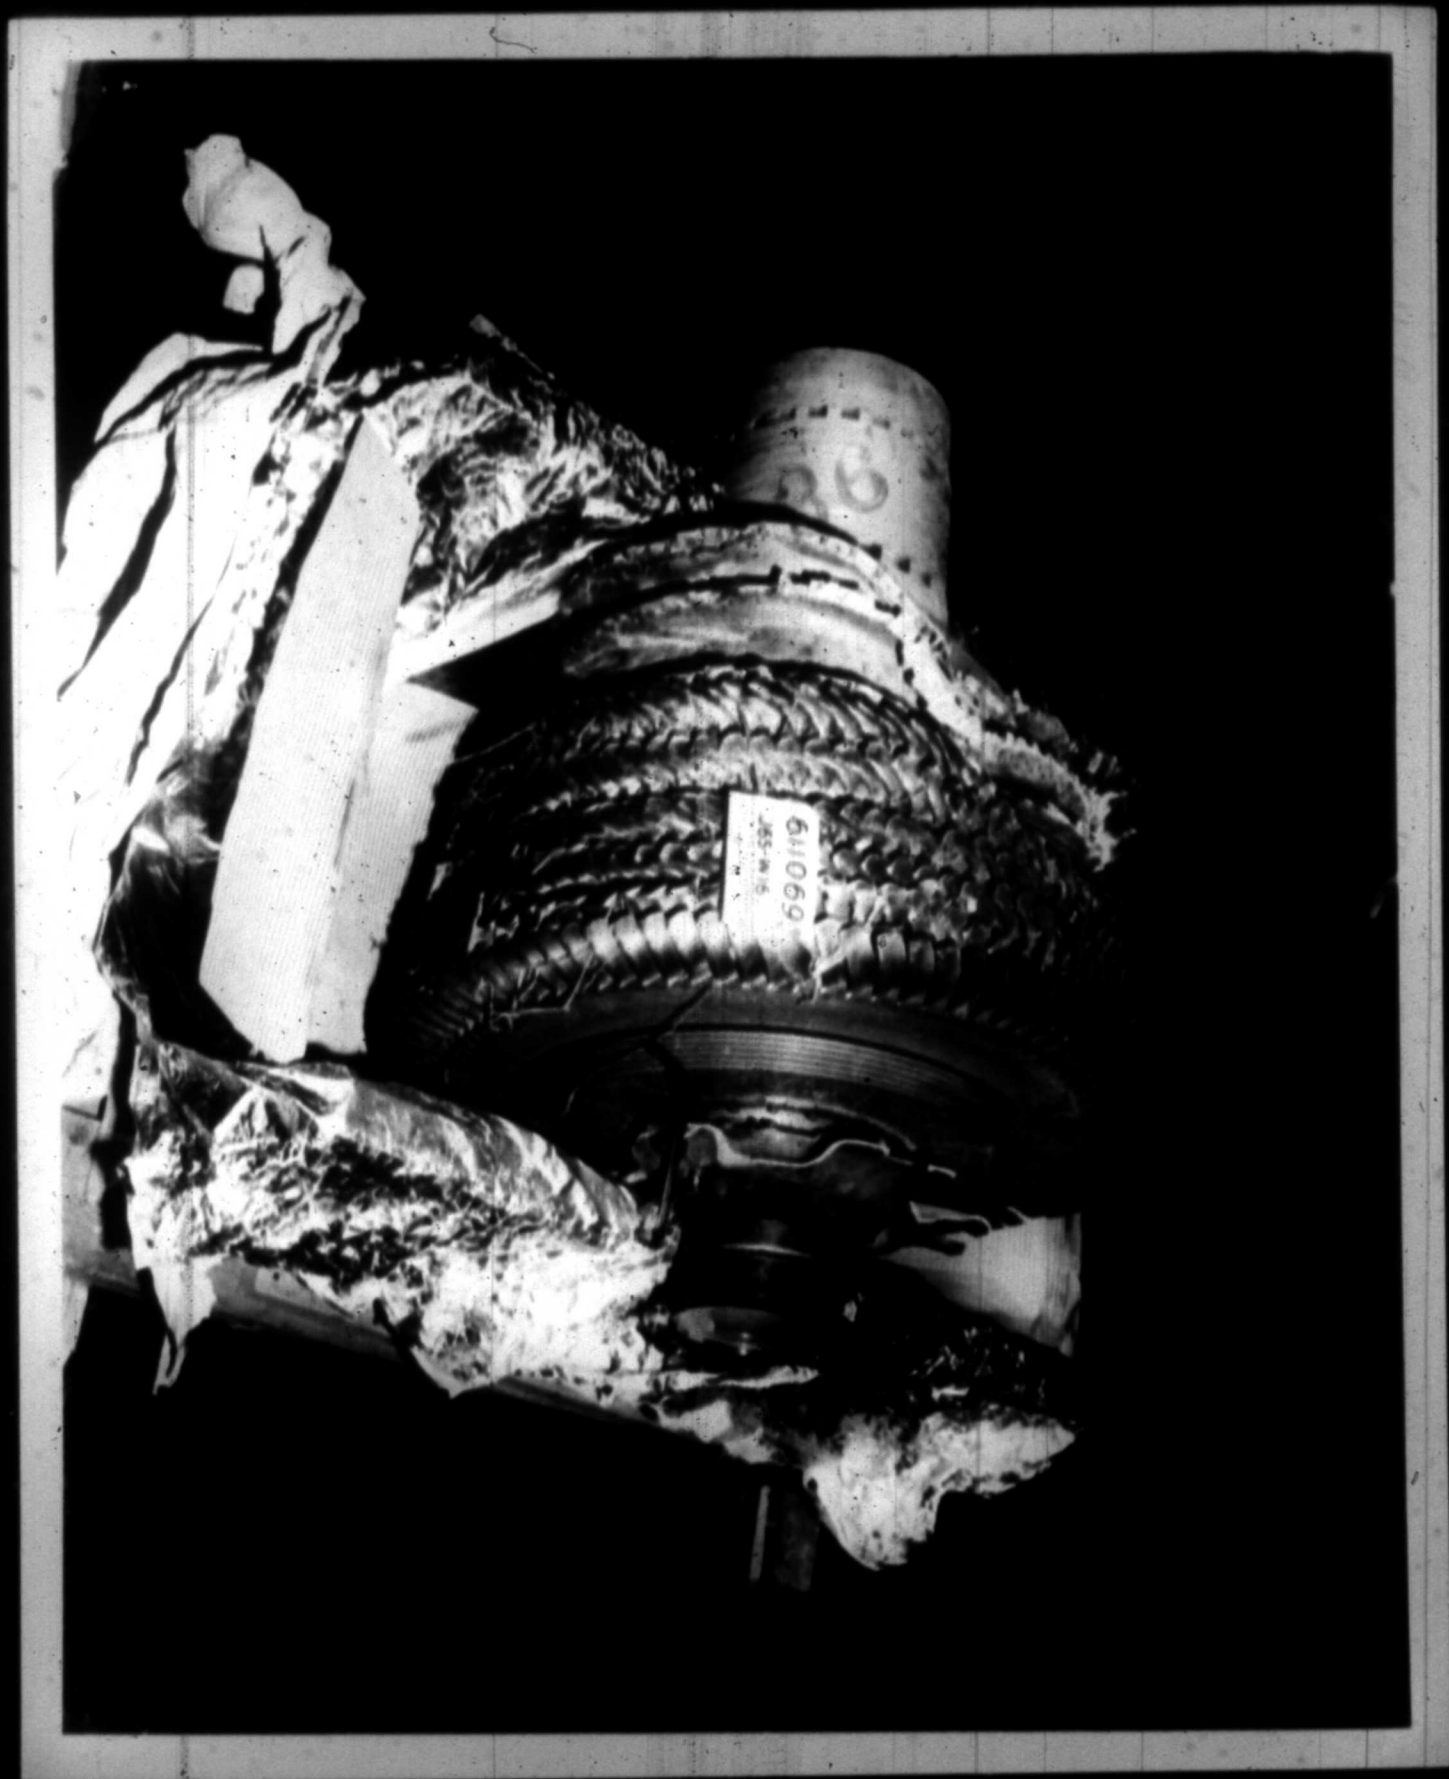
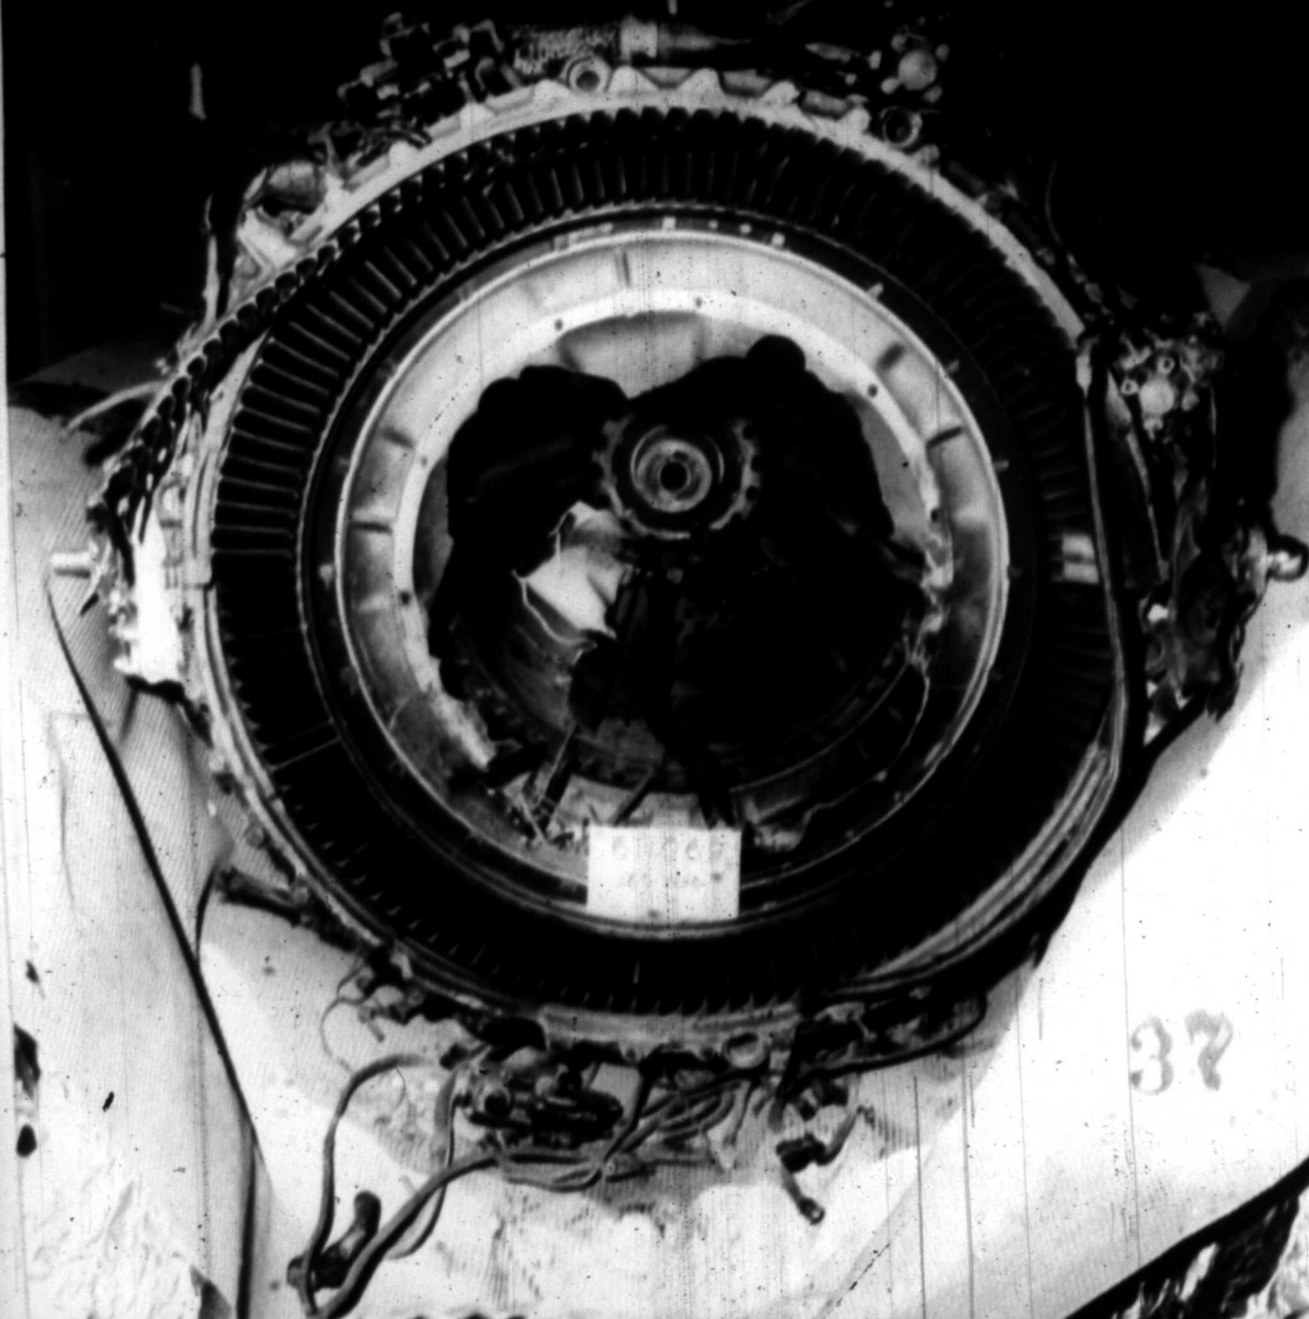
DISCREPANCIES Ref: BARR WESTDIST msg 152235Z Jun 1956 Encl: NAS Alameda photos NA27-31189, 31190, 31192, 31196
--

CONCLUSIONS Engine severely damaged from crash. Compressor rotor 1st stage destroyed down to the shaft. Compressor rotor 2nd and 3rd stage received separately from engine, no blades remaining. Remaining compressor rotor stages and blades were all uniformly folded down opposite the direction of rotation. Engine appears to have been operating in a power range at time of crash.

CONCLUSIONS: It is believed that engine was functioning properly at time of crash.
--
